CONSOLIDATION AND ADHESIVE REPAIR OF VOLCANIC TUFF
CASE STUDY: CONSERVATION OF VOLCANIC TUFF AT THE OLD
STONE CHURCH OF MISSION SAN JUAN CAPISTRANO,
SAN JUAN CAPISTRANO, CALIFORNIA

Evin Hewett Erder

A THESIS

1995

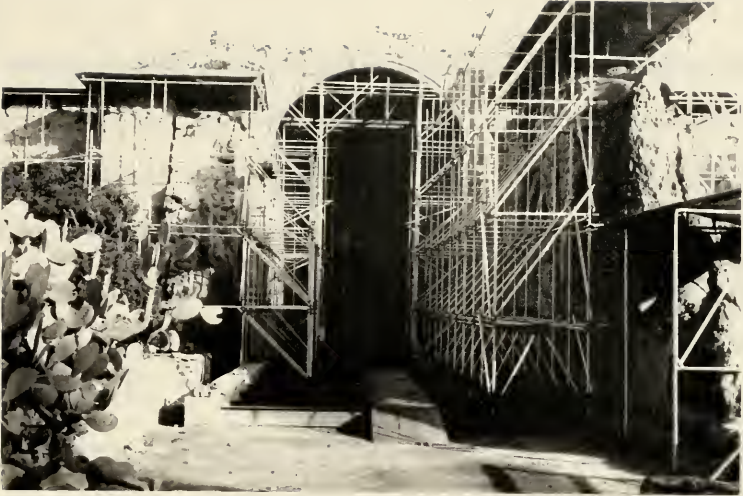
Fig. 2. View of nave of Old Stone Church, Mission San Juan Capistrano (1994).

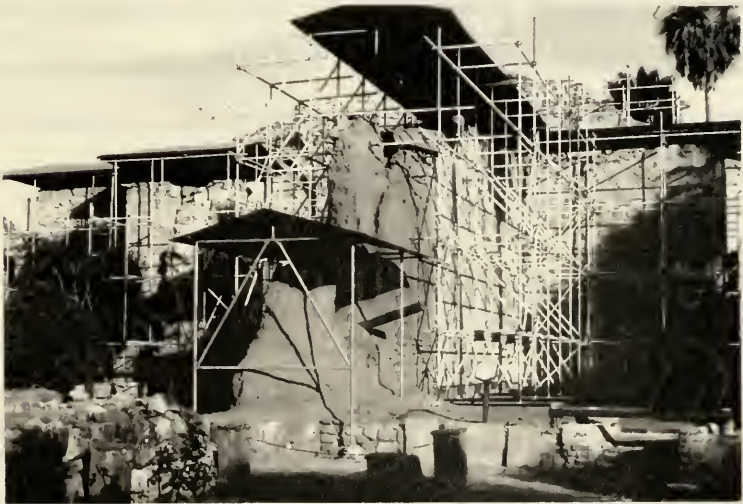
Fig. 3. View of exterior wall of nave and east transept of Old Stone Church (1994).

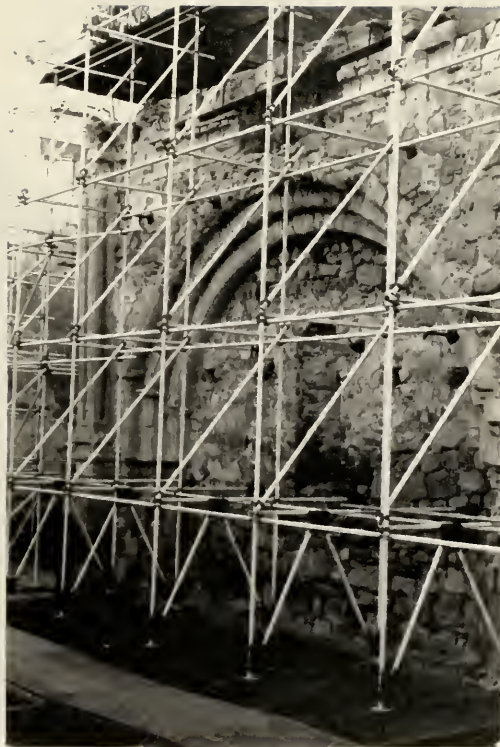
Fig. 4. View of east wall of nave, Old Stone Church (1994). The load-bearing stones are green and yellow sandstone. The stones in the cornice and pilaster are volcanic tuff, and the stones in the arch yellow sandstone and tuff. Fragments of lime-based plaster are present below the cornice and arch.

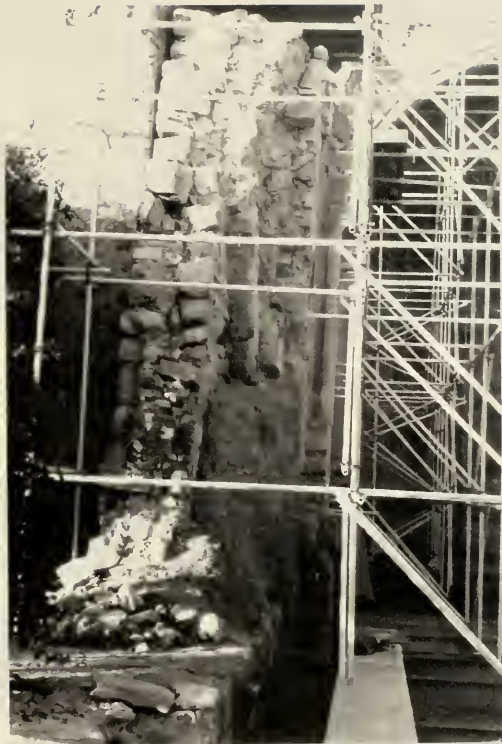
Fig. 5. West wall of nave, Old Stone Church (1994). The load bearing stones are yellow and green sandstone. The core of the wall consists of rubble stone, brick, and lime-based mortar.

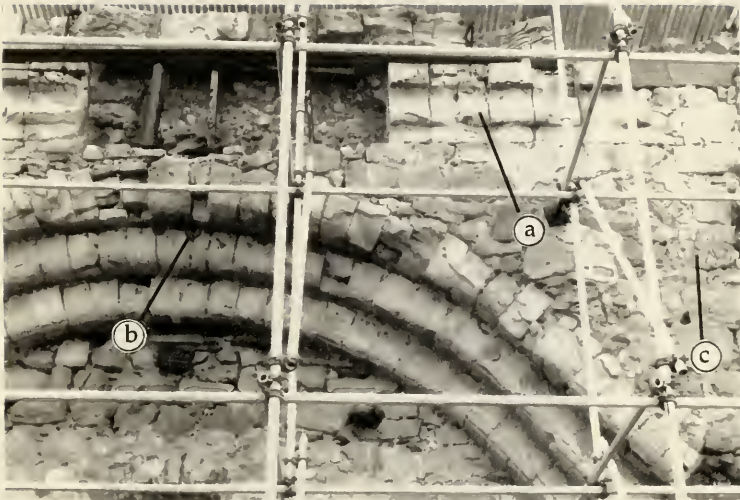
Fig. 16. East wall of nave. Stones in the cornice are volcanic tuff (a) and the stones in the arch are tuff and yellow sandstone (b); the load-bearing stones are yellow and green sandstone (c).

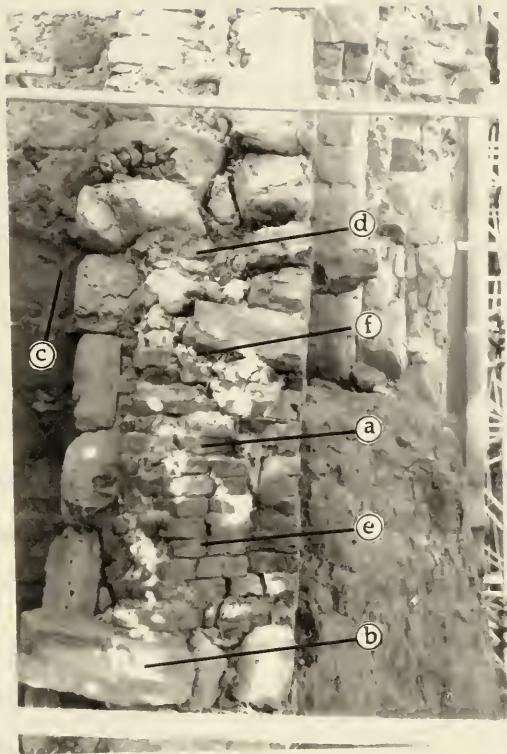
Fig. 17. Cross-section of west wall of nave. The outer and inner face of the wall consists of brick (a), yellow (b) and green sandstone(c), and the core of the wall of rubble stone (d), brick (e) and lime based mortar (f).
